PROJECT MEMORANDUM

To: Andy Kitzmann, Erie Canalway  
From: The Chazen Companies  
cc: Distribution List  
Date: January 25, 2021  
Re: Matton Shipyard - Summary of Environmental Conditions and Proposed Soil Remediation Plan  
Chazen Project No. 32069.00

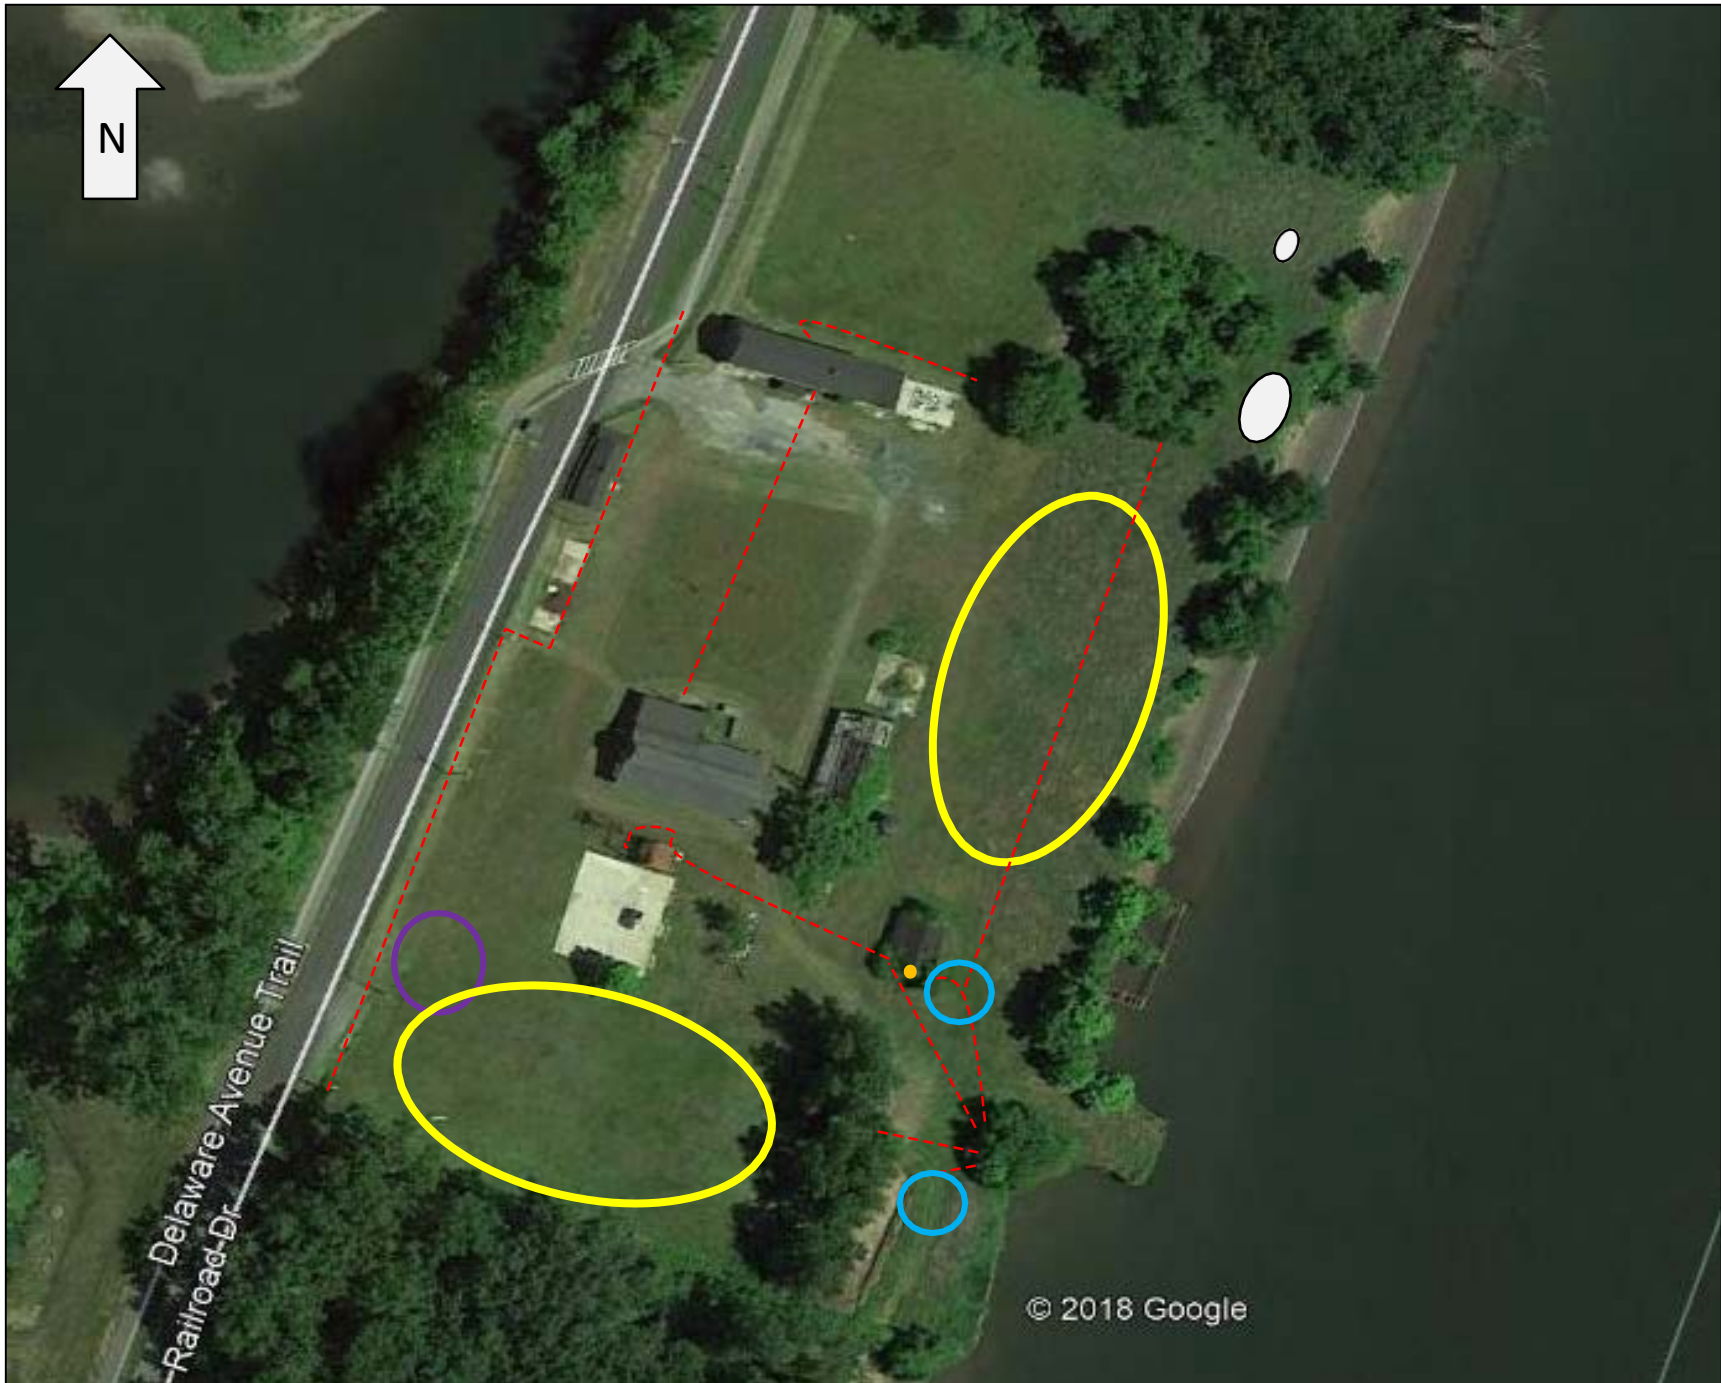
DRAWN BY AEM	FIGURE TITLE <b>GPR FINDINGS MAP</b>	
SCALE NTS	PROJECT LOCATION <b>FORMER MATTON SHIPYARD DELAWARE AVENUE, VAN SCHAICK ISLAND COHOES, NY</b>	
DATE 8/2/19		
PROJECT # 190729ENVA	PREPARED FOR: ERIE CANALWAY HERITAGE FUND, INC	FIGURE NUMBER 1

The SI included a GPR survey of the project area to identify metallic anomalies that could be indicative of in-place underground storage tanks, disturbed soils, pipes/drains, electrical conduits, etc. The GPR survey identified several linear features consistent with inground pipes or electrical conduit, two potential USTs, an old building foundation, and two areas with an apparent abundance of near surface shallow metallic debris. The sources of these subsurface metallic anomalies have not been positively determined.

The SI indicated that there was metal debris and other buried materials at various locations throughout the Site but did not indicate the presence of buried tanks. A pipe protruding from the ground near a concrete pad, just east of a concrete slab adjacent to a wood-framed garage near the sandblasting silo, resembled a sump or drain cleanout rather than a tank fill port. No underground tank was encountered. Evidence of petroleum contamination was not encountered at SB-3.

A possible fill port was previously identified adjacent to the former pipe shop near boring location SB-4. During the GPR survey, a possible tank outline was identified with the metal detector, however; the GPR survey did not show typical UST indications. No evidence of contamination was encountered at SB-4. Further investigation has indicated that the pipe has an elbow and is threaded and is not a fill port.

Although SI activities did not indicate the presence of USTs, the only way to determine that USTs are not present at locations of GPR anomalies is to excavate test pits at those locations. Based on the data that is available, and the demonstrated potential for natural attenuation processes to substantially reduce concentrations of petroleum-related compounds in subsurface media over time, there is limited potential risk to human health or the environment in connection with such conditions at the Site. Further investigation of such potential risks must be weighed against the potential to disturb sensitive cultural resource. Should subsurface activities be performed in these areas in the future, or should a regulatory agency require further investigation, appropriate measures should be taken to protect human health and the potential presence of cultural resources.

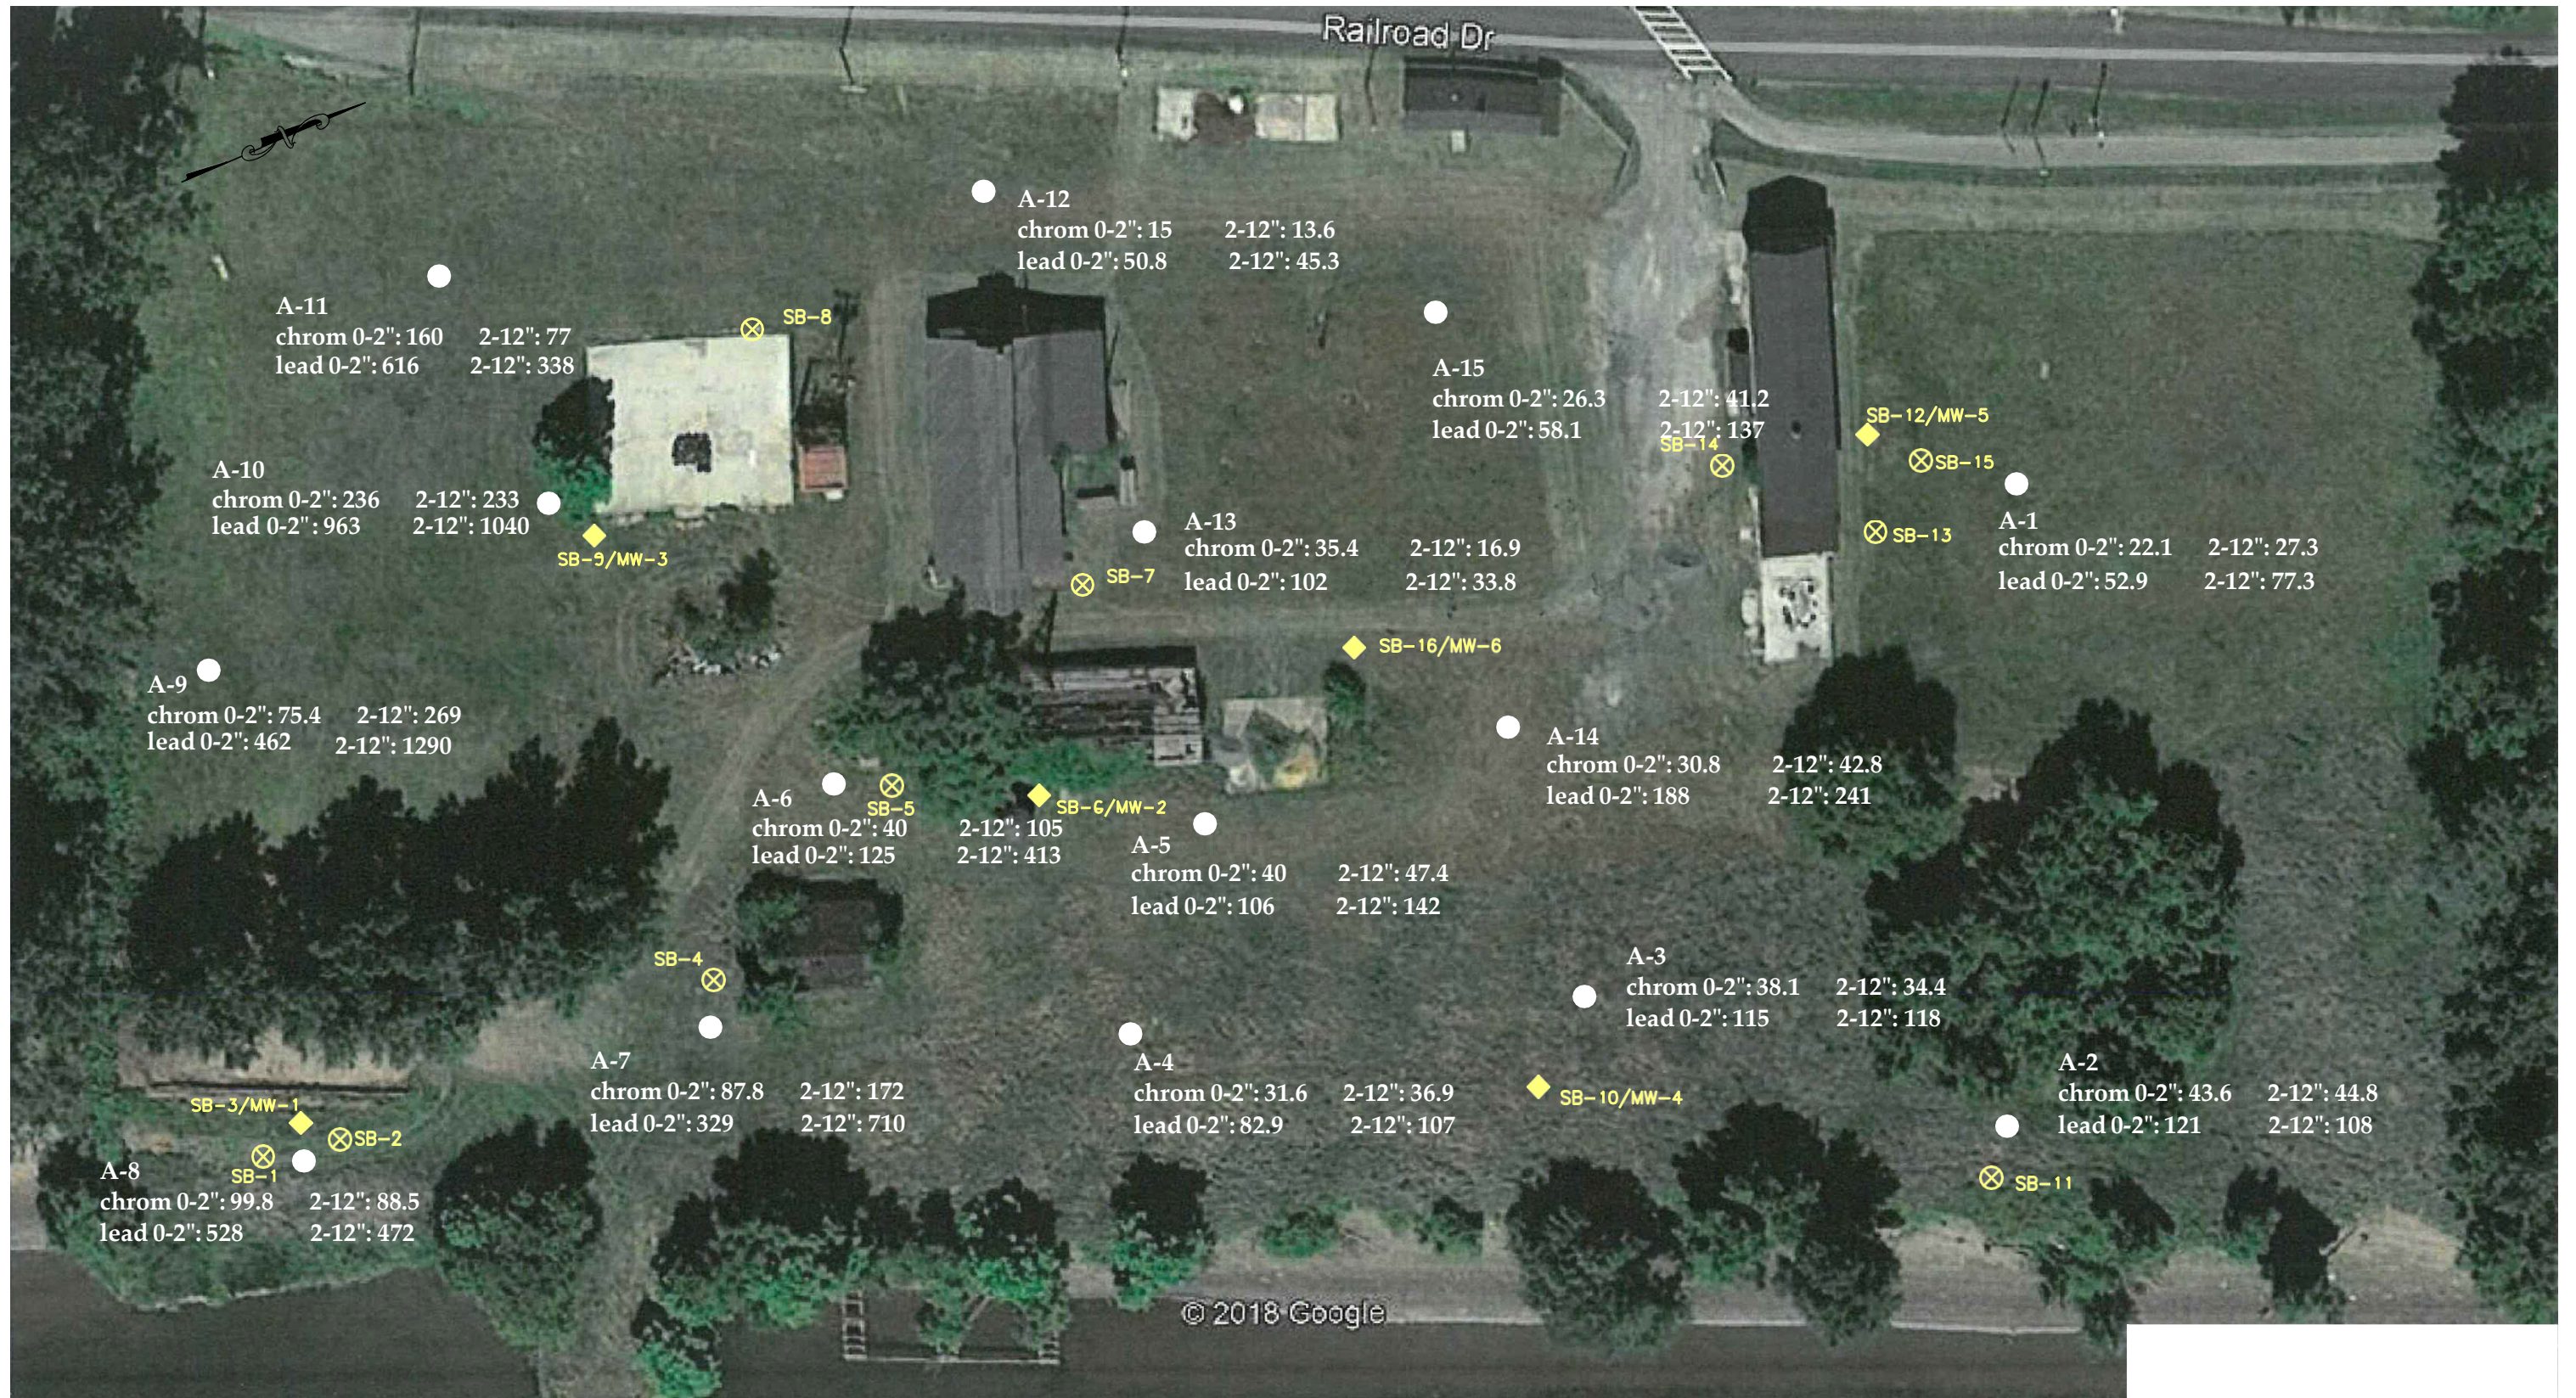
DATE: 08/29/19	SCALE: AS SHOWN
PROJECT NO. 190729ENVA	
DRAWN BY: MTG	
CHECKED BY:	
DRAWING NO.	FIGURE 2

Petroleum odors and a VOC reading of 48 ppm was detected at 9 feet bgs at SB-12, in the vicinity of a former UST. No odors, staining, or PID measurements greater than 5 ppm were detected in the recovered soil except at SB-12 where a gasoline odor was detected. Soil sample analyses did not indicate the presence of petroleum-related compounds at concentrations exceeding UUSCOs.

The SI Reports indicated that concentrations of SVOCs exceeded the NYS GWS for benzo(b)fluoranthene and benzo(k)fluoranthene in MW-3, MW-4 and MW-6, and chrysene and indeno(1,2,3-cd)pyrene in MW-4 and MW-6. VOCs were not detected in samples collected from six temporary wells installed across the site. Acetone was detected in soil and groundwater samples collected at several locations; however, the presence of this common laboratory artifact at the detected concentrations does not present as a project site contaminant.

basis for decision-making.<sup>1</sup> The 2019 sampling results indicate the presence of lead in soil at concentrations exceed the CUSCO, which 1000 ug/kg for lead, at A-9 from 2 to 12 inches bgs (1,290 mg/kg) and at A-10 from 2 to 12 inches bgs (1040 mg/kg.)

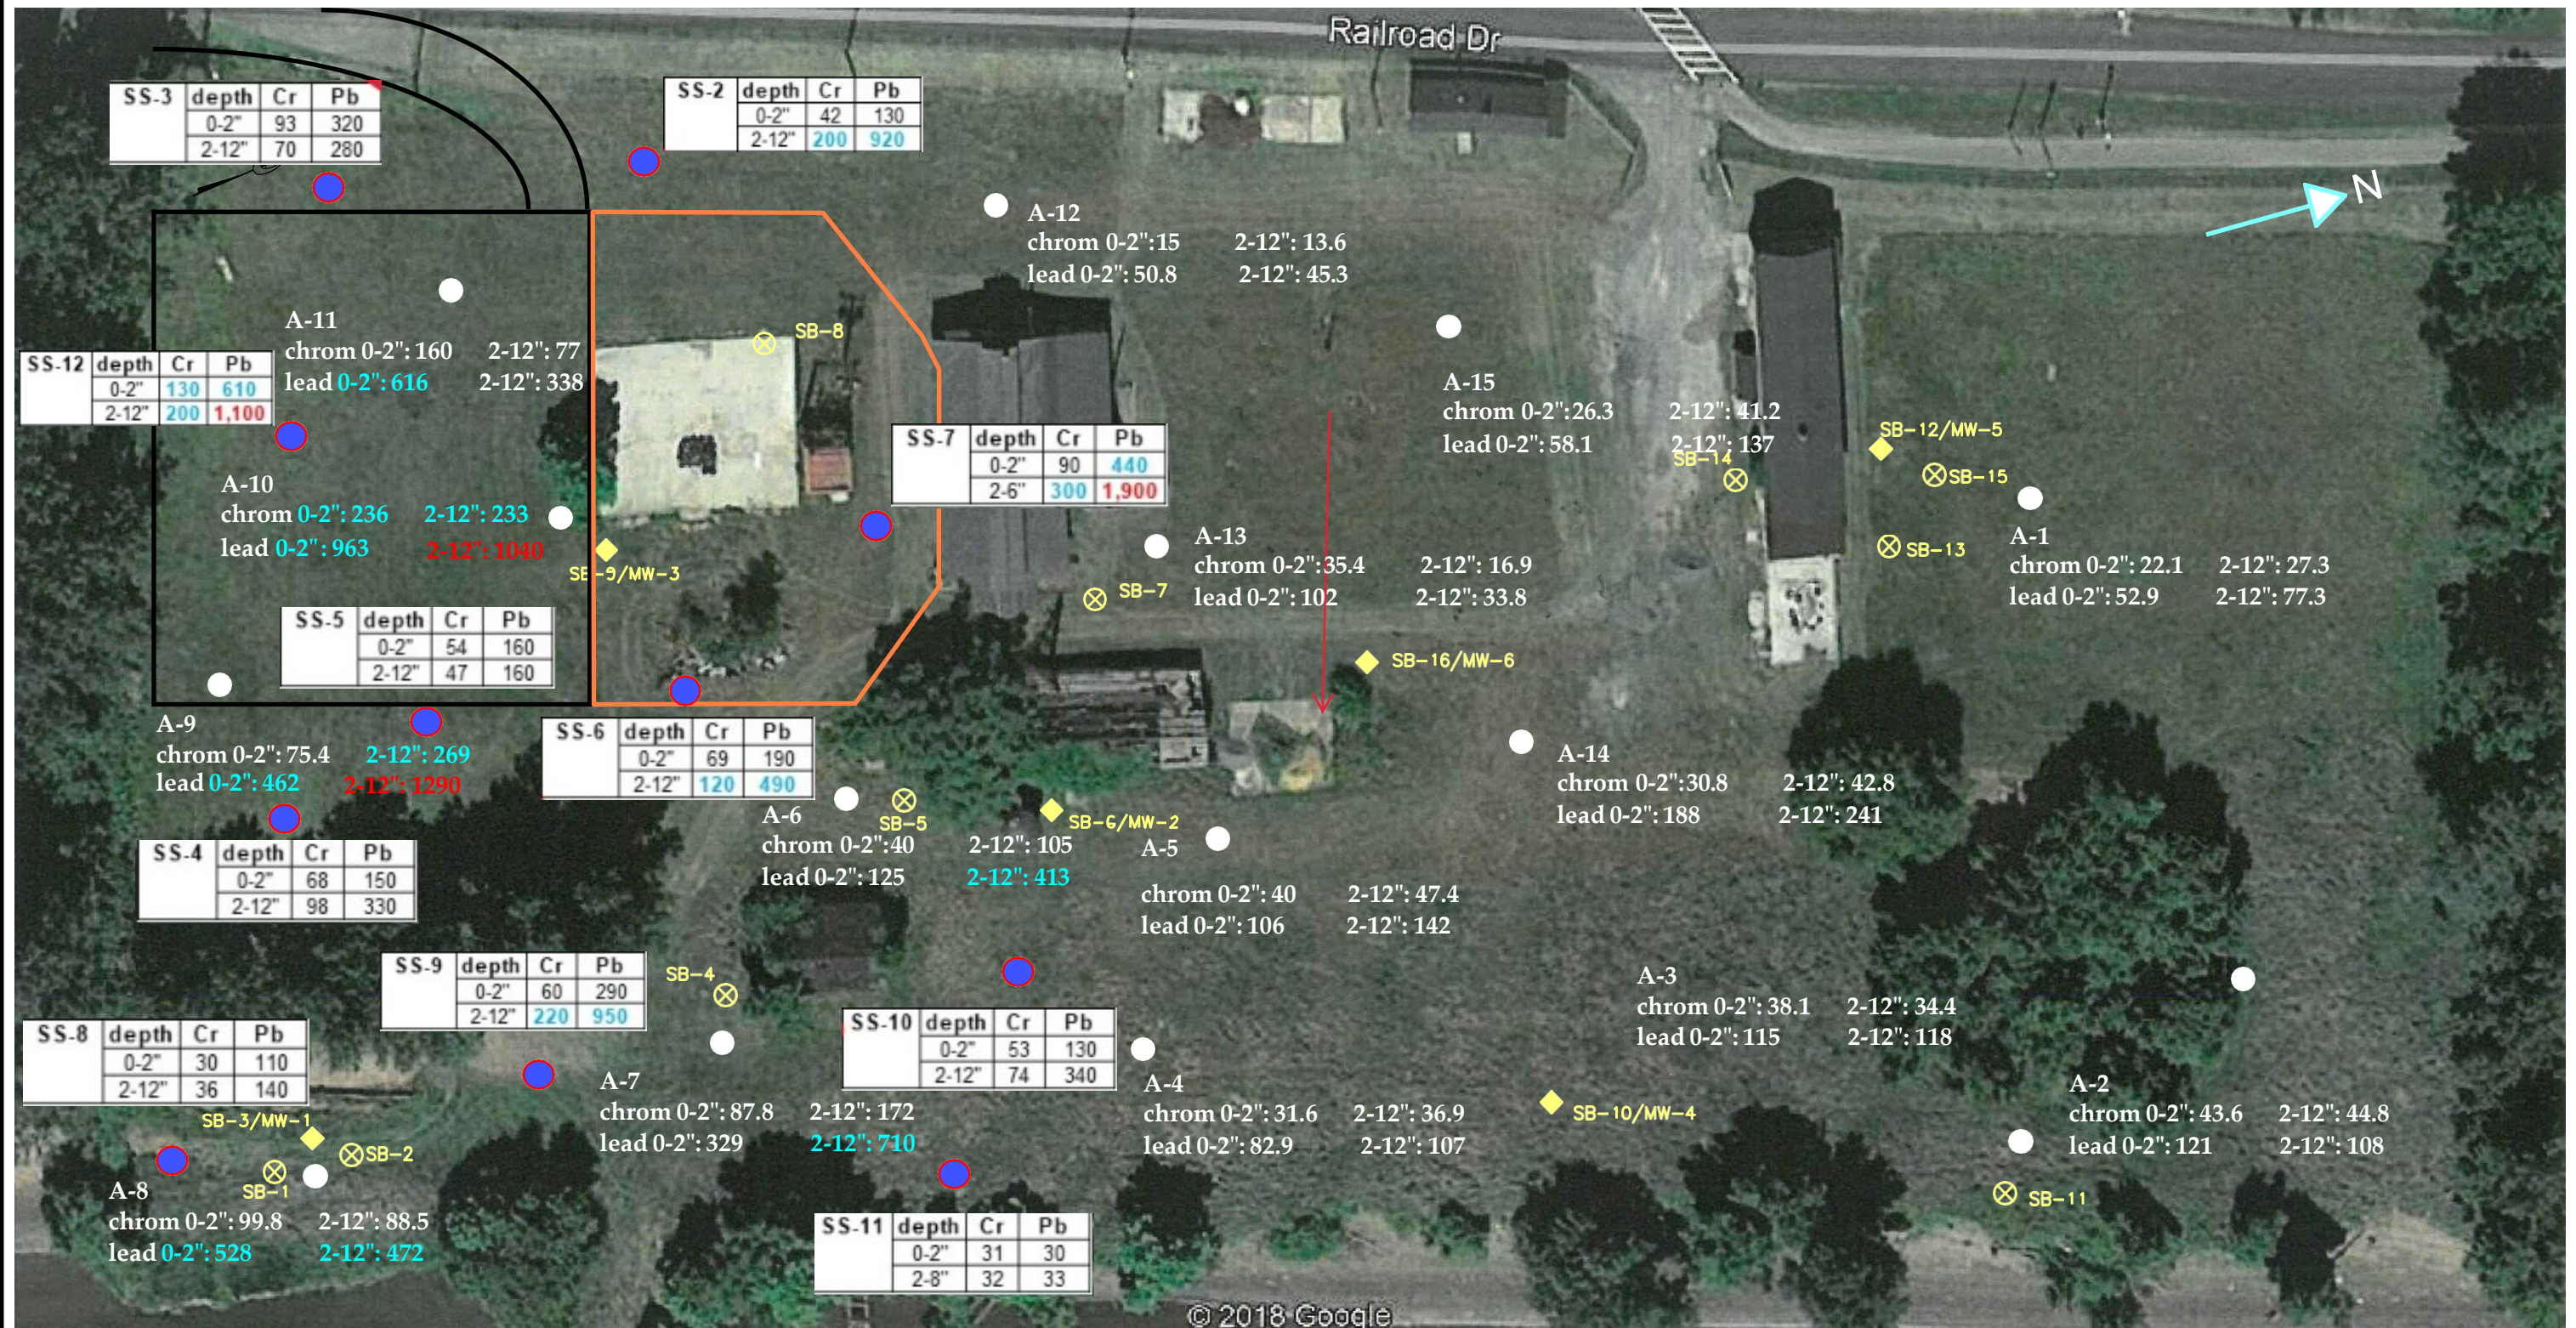
Figure 3

The December 2002 supplemental soil grab sampling results indicate the presence of lead in soil at concentrations exceed the CUSCO at SS-7 from 2 to 6 inches bgs (1,900 mg/kg) and at SS-12 from 2 to 12 inches bgs (1100 mg/kg.) The waste characterization results further refined the disposal options and related costs for material targeted for off-site disposal from the southern portion of the property.

SS-12	depth	Cr	Pb
	0-2"	130	610
	2-12"	200	1,100

SS-7	depth	Cr	Pb
	0-2"	90	440
	2-6"	300	1,900

The remedy will consist of the removal and off-site disposal of approximately 570 cubic yards of material. The southernmost portion of the Site would be capped with a gravel parking lot. Further north, an area surrounding the exposed concrete slab to the south of the woodworking shop will be capped with clean topsoil and re-seeded.

Specifically, in the southernmost portion of the Site, the selected remedy consists of the excavation and off-site disposal of the top 6 inches of soil across of an area approximately depth of 6 inches in the southern portion of the site. An area approximately 130 ft x 150 ft would be capped with installation of a demarcation layer, and placement 6 inches of crushed stone and gravel to serve as an engineering control that will prevent direct contact with subsurface soils and act as a facility parking lot (Area A). The driveway to this parking lot would also constitute a cap and could be located on top of the former railspur.

Further north, the top 6 inches of soil in the approximately 100 ft x 130 ft area to the north of the parking lot would be removed for off-site disposal followed by the installation of a demarcation layer and the placement 6 inches of top-soil (Area B.) The area would then be re-seeded. The 75 ft x 75 ft concrete pad located to the north of the proposed parking area would remain in place and serve as a cap and support for potential future structure.
