# Amenities Study

Conditions Evaluation and Long-Term Planning for  
Recreational Amenities on the Erie Canal

MARCH 2025

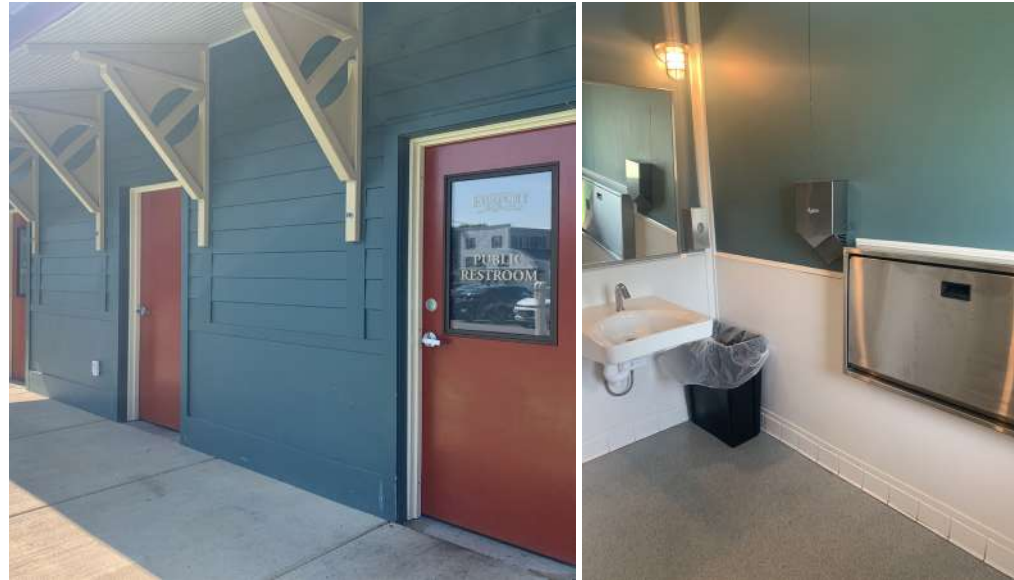
### GOOD - Permanent Restroom

These single-occupancy permanent restrooms were clean, functional, and well maintained. They were designed to maximize accessibility for all users. (Fairport)

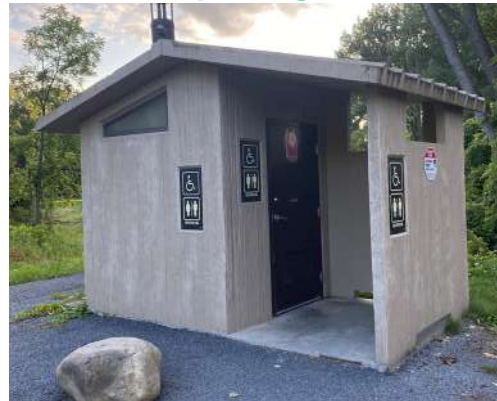
### GOOD - Composting Toilet

This self-composting toilet is well positioned near a picnic area and parking lot and enhances the aesthetics of the area. (Montezuma)

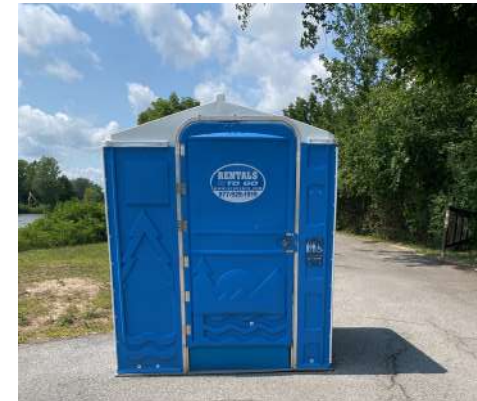
### GOOD - Portable Toilet

This portable toilet near Lock 33 is visible, located on a paved surface, and well maintained. It is also sized appropriately for those who use a mobility device or need assistance. (Rochester)

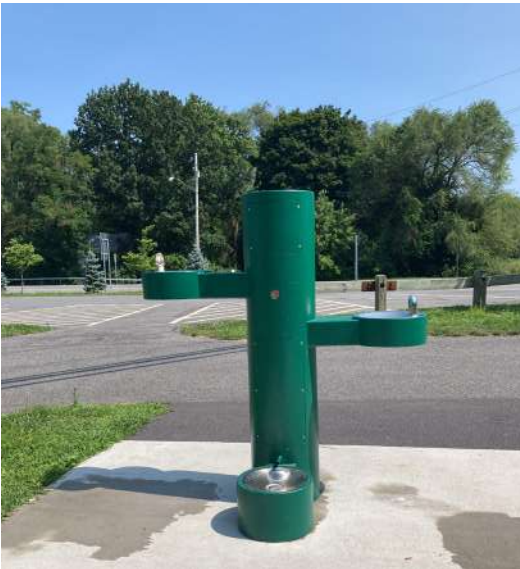
### GOOD

This drinking fountain provides options for users of all abilities as well as dogs. The material is in good condition, it is easily visible from the Erie Canalway Trail, and can be accessed from a paved surface. (Pattersonville)

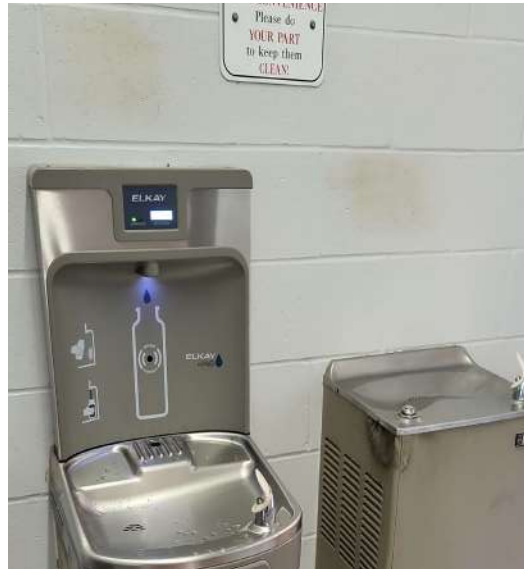
### GOOD

This drinking fountain provides options for bottle filling as well as drinking. Because it is located indoors, signage would help to direct users to it. (Amherst)

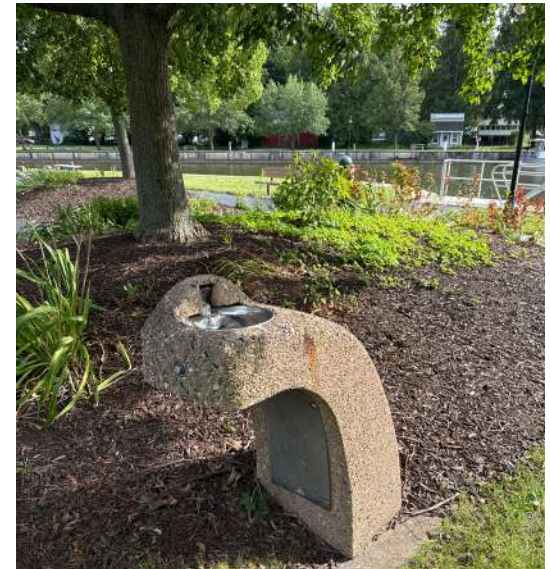
### FAIR

The stone drinking fountain is beginning to deteriorate but is still functional. Its location is tucked away from the Erie Canal/NYS Canalway Water Trail. (Baldwinsville)

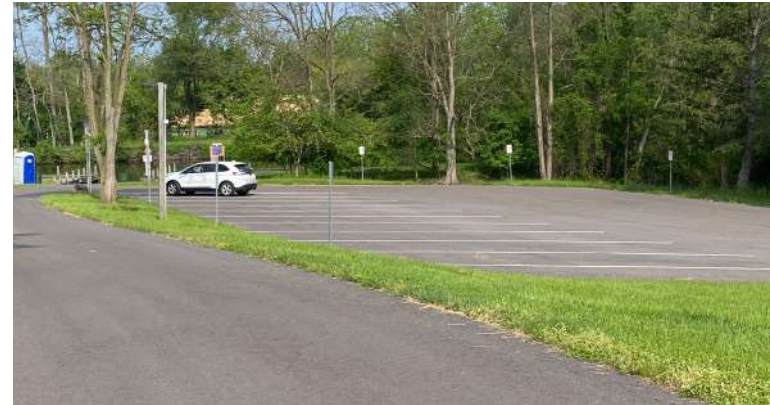
### GOOD

The pavement in this parking lot is in good condition and the spaces were clearly striped and signed. The parking lot also has designated spaces for boat trailers. (Ayrault Road Boat Launch, Perinton)

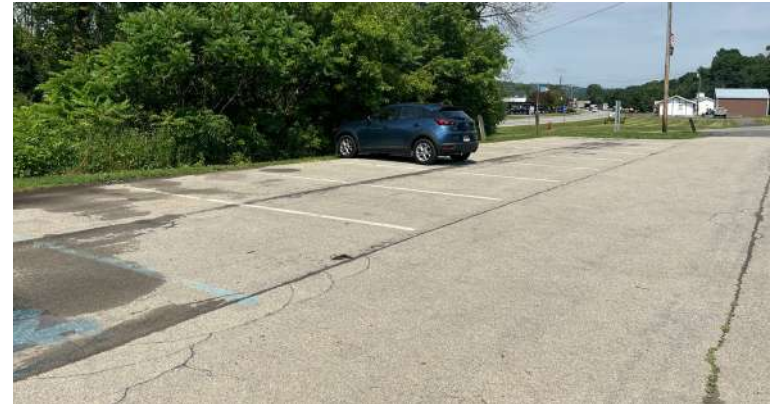
### FAIR

This lot is beginning to show cracks and signs of wear. (Canajoharie)

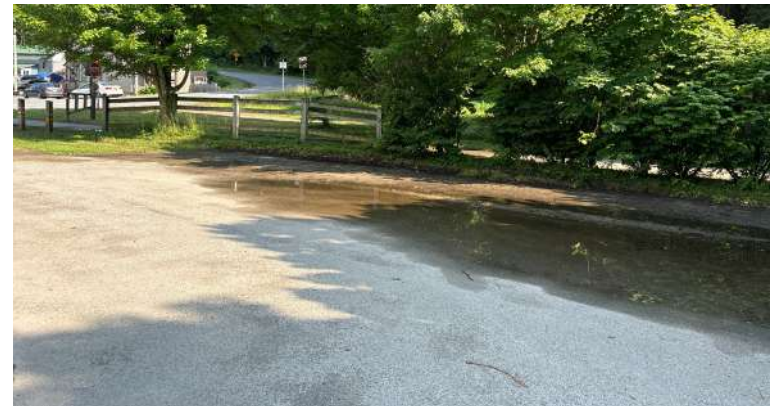
### POOR

Significant ponding prevented much of this parking lot from being used. (Sprakers)

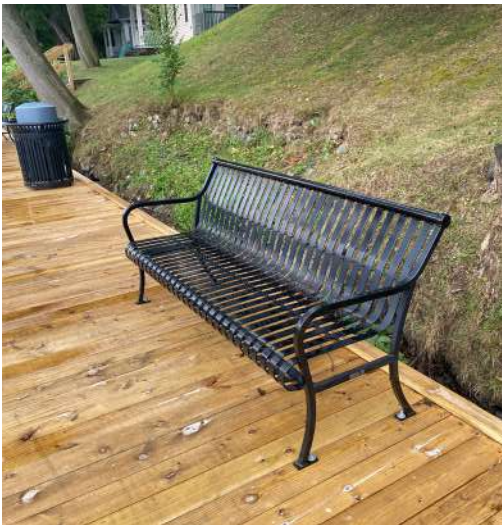
### GOOD

This bench was securely installed, its surface was free of wear, and it was well positioned along the waterfront. (Pittsford)

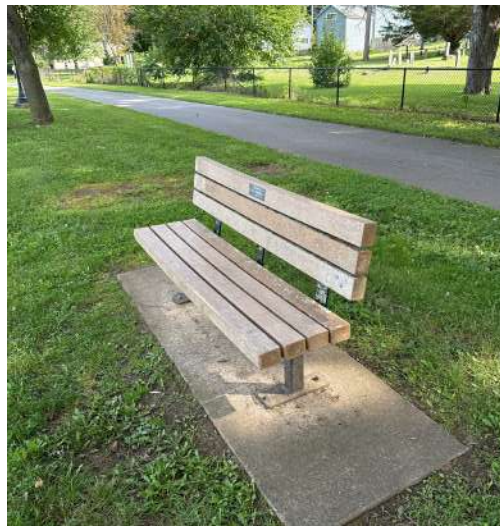
### GOOD

This wooden bench was in good condition but was not connected to the paved path, creating a barrier to accessibility. (Baldwinsville)

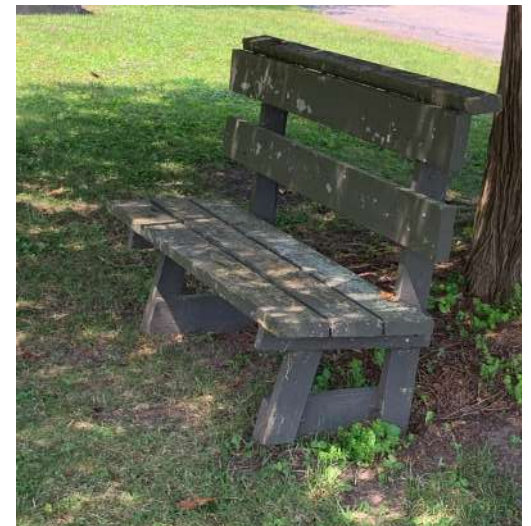
### POOR

The material of this bench was deteriorating, the bench structure was in disrepair, and it is not accessible from the Erie Canalway Trail. (Rome)

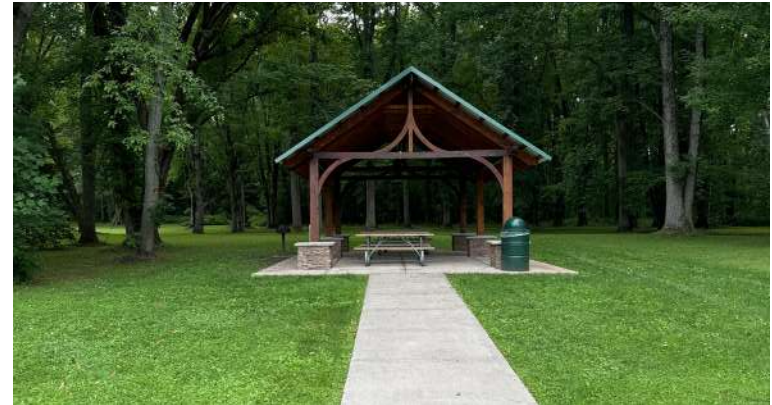
### GOOD

The shelter, tables, and waste receptacles are in good condition, the area is clean and well maintained, and there is a clearly marked, concrete path with no visible barriers to accessibility. (Baldwinsville)

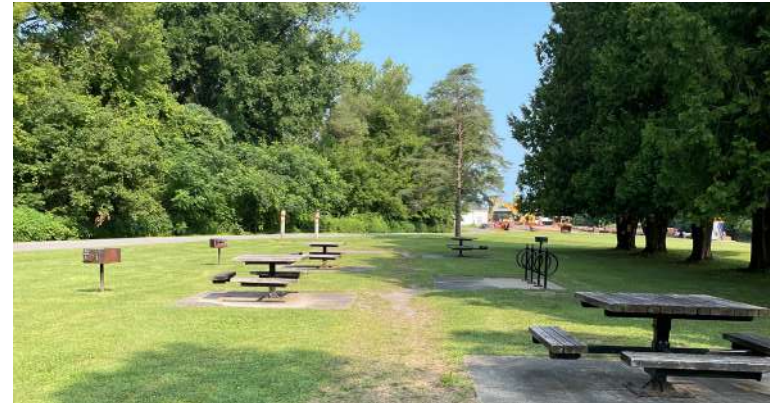
### FAIR

This picnic area shows signs of wear on the tables, grills, and grounds, but is still functional. (Marcy)

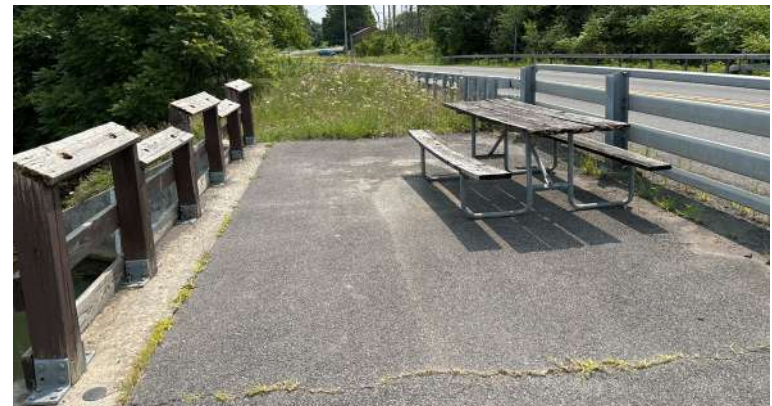
### POOR

The benches are sagging and the material is worn and splintered. Its placement against a guard rail prevents full use. Picnic areas like these should be re-evaluated for better placement. (Kirkville)

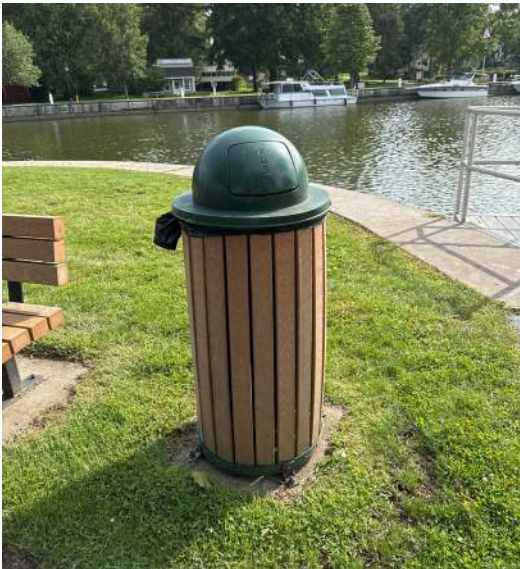
### GOOD

This waste receptacle is made of durable material and shows no signs of wear. It is logically located near a picnic area. (Paper Mill Island, Baldwinsville)

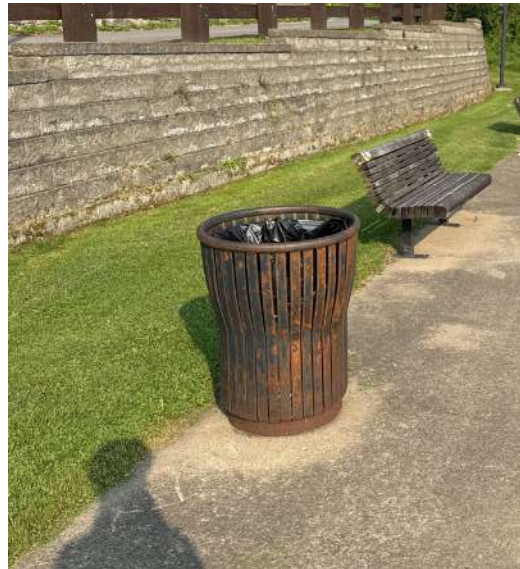
### FAIR

This waste receptacle shows some signs of wear but is generally functional and conveniently positioned at a public marina. (Utica)

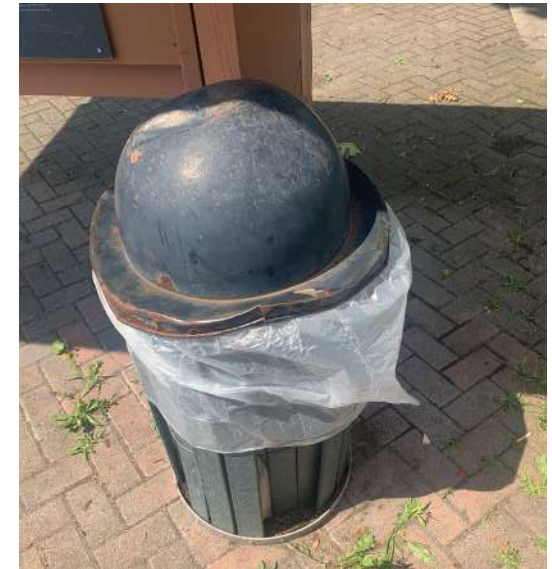
### POOR

This receptacle is dented and damaged with noticeable surface wear, making it difficult to use and detracting from a positive experience. (Jordan)

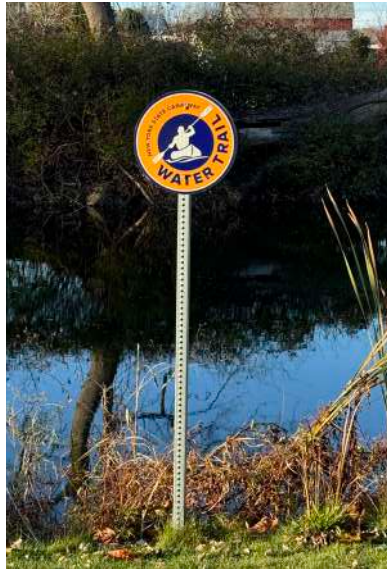
### GOOD

NYS Canalway Water Trail Markers, which were installed in 2020, were generally in good condition. (Palmyra Aqueduct Park)

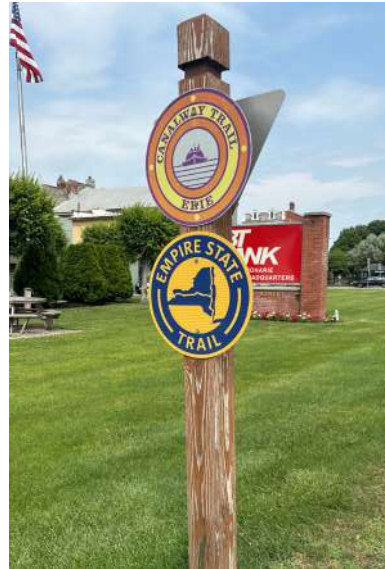
### GOOD

These Erie Canalway Trail and Empire State Trail markers are easy to see and the color is intact. Co-locating these two markers helps with branding and navigation. (Canajoharie)

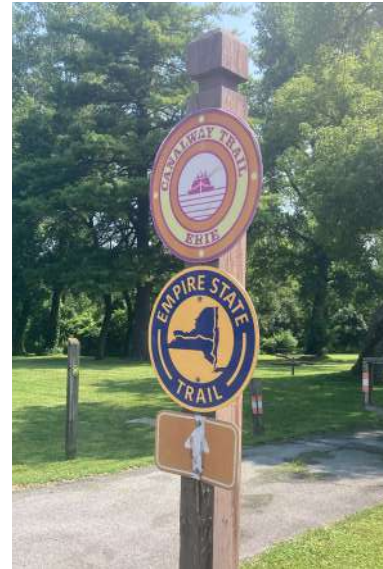
### FAIR

In this example, the Empire State Trail marker is in good condition but the Erie Canalway Trail marker is beginning to fade and the arrow is damaged. (Camillus)

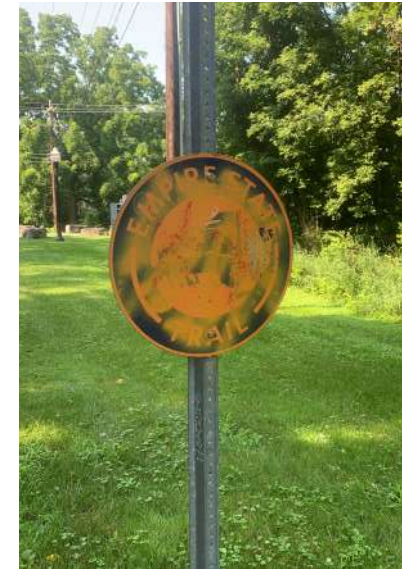
### POOR

The Empire State Trail marker has been vandalized, making it illegible, and there is no Erie Canalway Trail marker visible, which can cause confusion. (Newark)

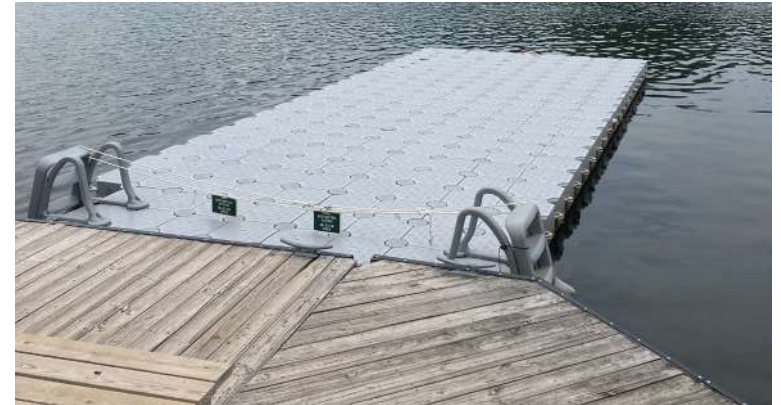
### GOOD

This low profile dock is connected to a stable surface that makes it easy to carry a kayak or canoe to the water. The material is durable and well maintained. (Amsterdam)

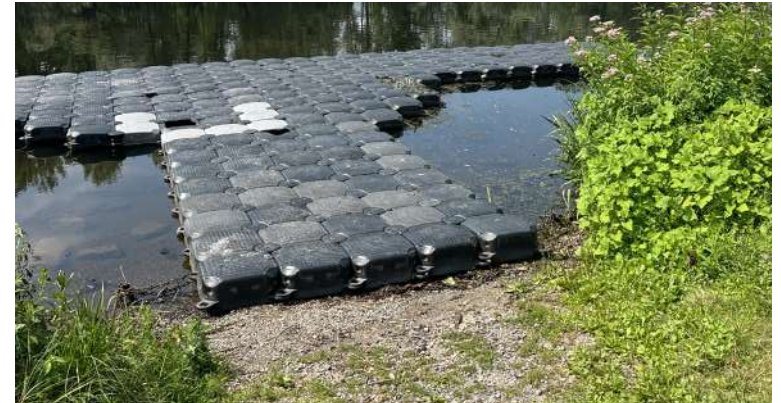
### FAIR

This low profile dock is made of a composite of rubber tiles that show wear in some places. A smooth, stable connection from land to the dock would make it easier to access. (Oneida)

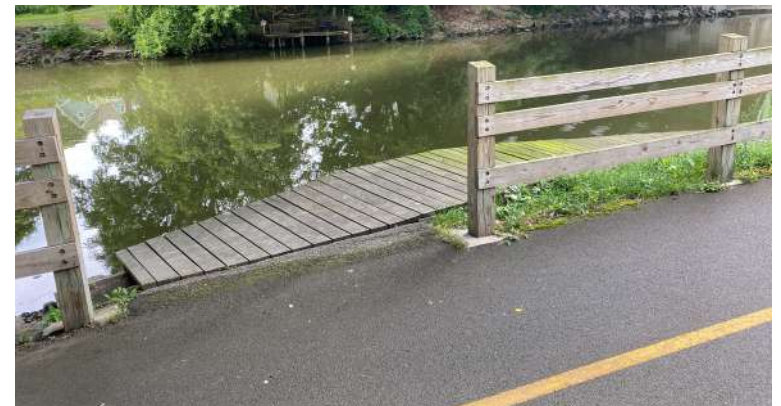
### POOR

This low profile dock is sagging and does not protrude beyond the rocky bank into the water, making it extremely difficult to use. Launches like this should be evaluated for decommissioning. (Pittsford)

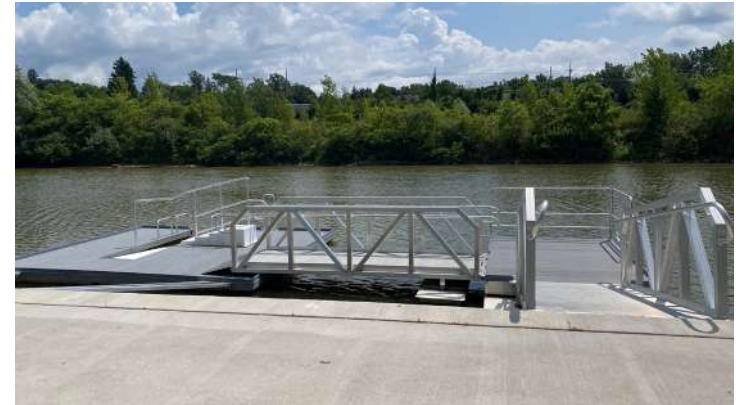
This launch had all components in good working condition and was free from debris or wear. (Pittsford)

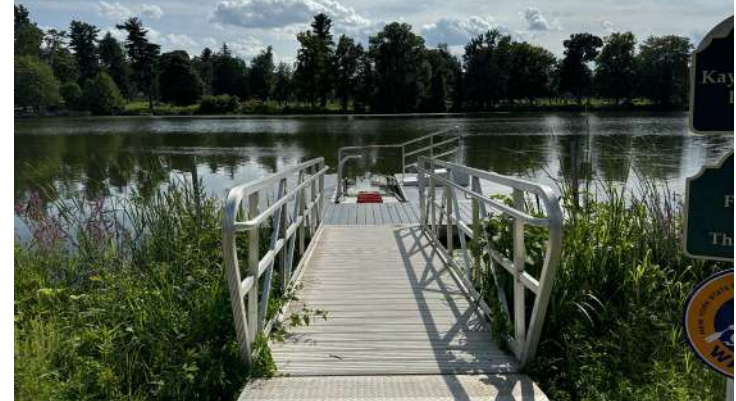
### FAIR

Some overgrowth can be seen at this adaptive launch but it was well maintained overall and had clear signage. (Baldwinsville)

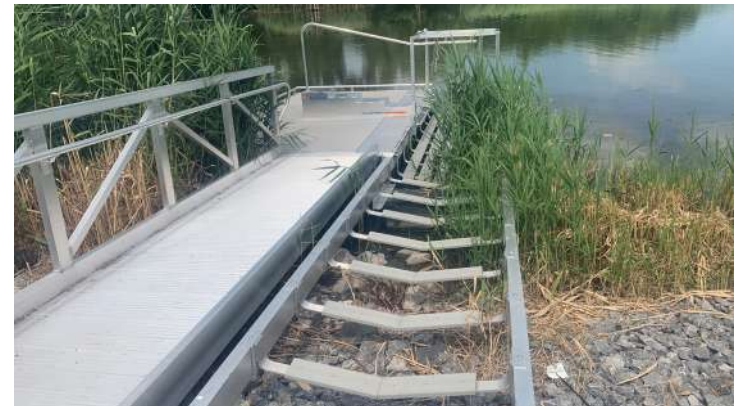
### POOR

This adaptive hand launch has overgrowth inhibiting use of the launch ramp. This launch was inventoried at Syracuse Inner Harbor and is technically outside the bounds of the NYS Canalway Water Trail.

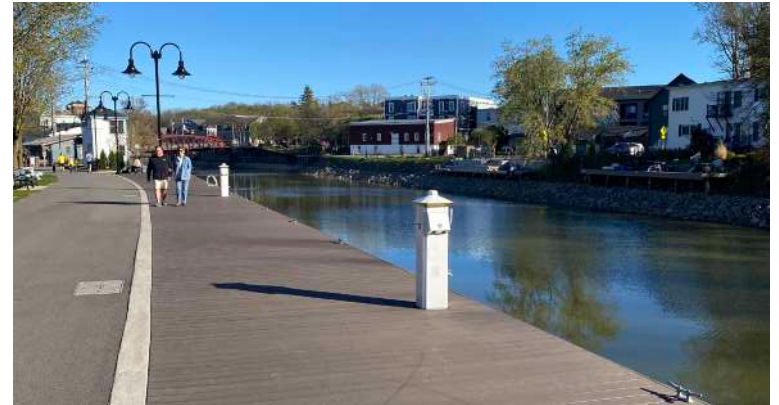
### GOOD

This marina has a new, durable surface and has no grade separation between the Erie Canalway Trail and the dock. Power and water pedestals are available, along with showers and restrooms. (Fairport)

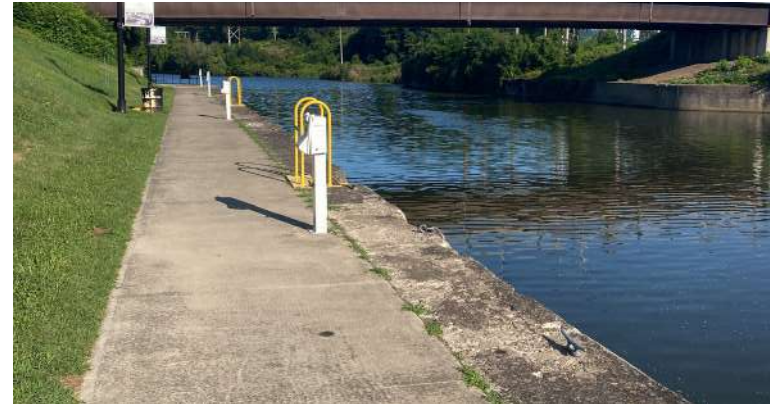
### FAIR

This image shows the northern side of the marina in Lyons. There are signs of the wall deteriorating but it generally functions well, amenities are easy to connect to, and it remains a popular stop for boaters. (Lyons)

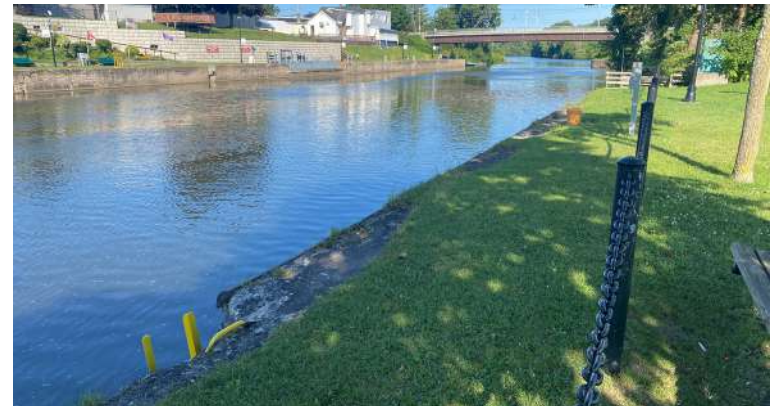
### POOR

This image shows the southern side of the marina in Lyons, where the wall is significantly deteriorated, power pedestals were padlocked to prevent use, and a post-and-chain fence separates the water's edge from amenities in the adjacent park. (Lyons)

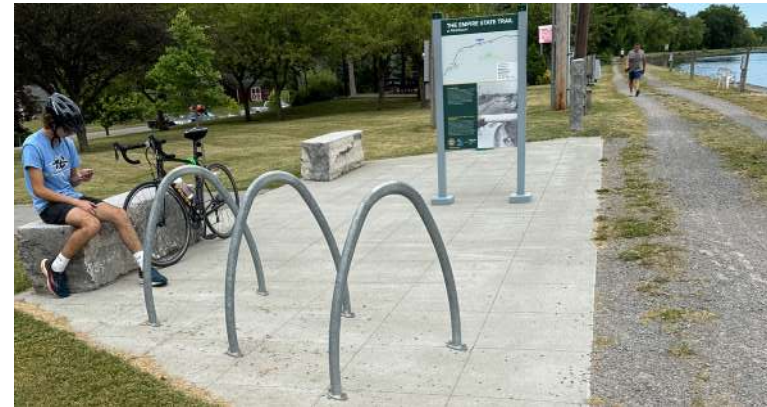
### GOOD

This bike rack is a simple and effective model that allows bicycles to be secured at two points without falling down. The material is in good condition and the rack is secured to a concrete pad. (Middleport)

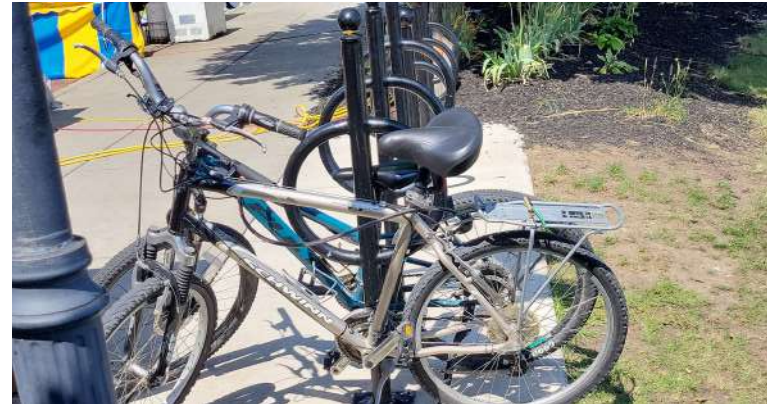
### GOOD

This bike rack is well positioned in an activated area and shows no signs of rust or wear. The rack is secured and on a firm, stable surface that is easy to access with a bicycle. (Tonawanda)

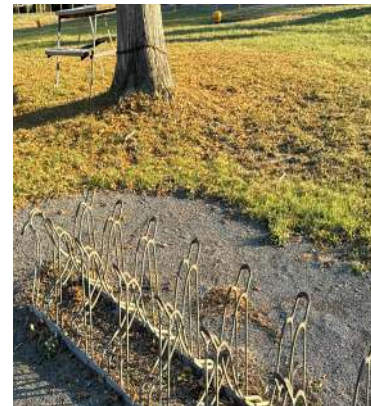
### POOR

These outdated bike racks only secure the wheel and leave the rest of the bike vulnerable to theft. The surface is rusted, the rack is not secured to the ground, and it isn't intuitive to use. (Macedon)

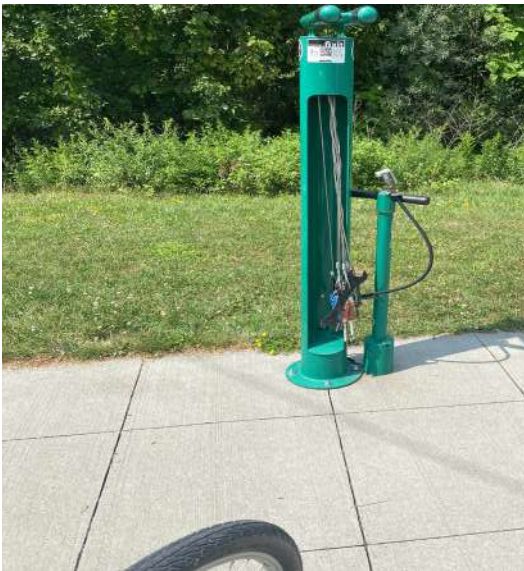
### GOOD

This repair station is installed on a firm, stable surface in a visible location along the Erie Canalway Trail. The components are commercial quality and show no signs of wear. (Rochester)

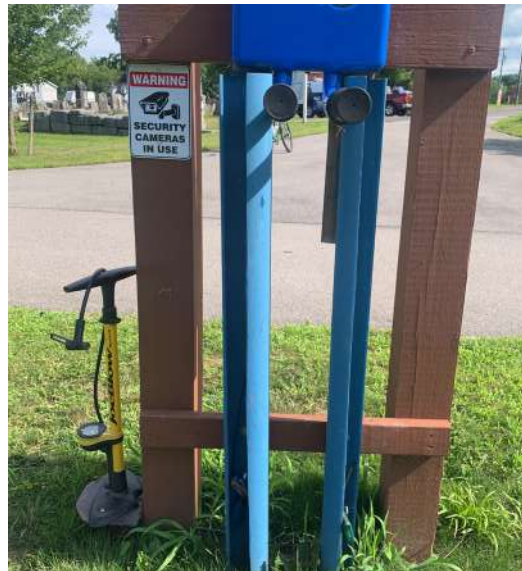
### FAIR

This repair station appears to have been custom built to serve this need, adding a retail air pump. Those designed for heavy public use are more durable, like the one in the image to the left. (Mohawk)

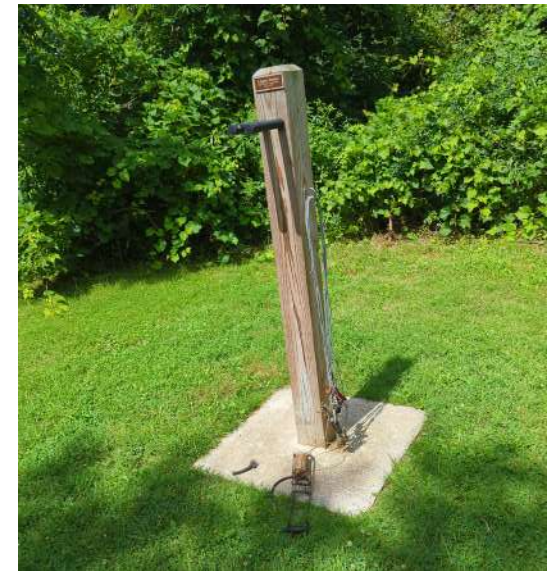
### POOR

Several tools at this repair station appear to be rusted beyond use and the pump is broken. (Cohoes)

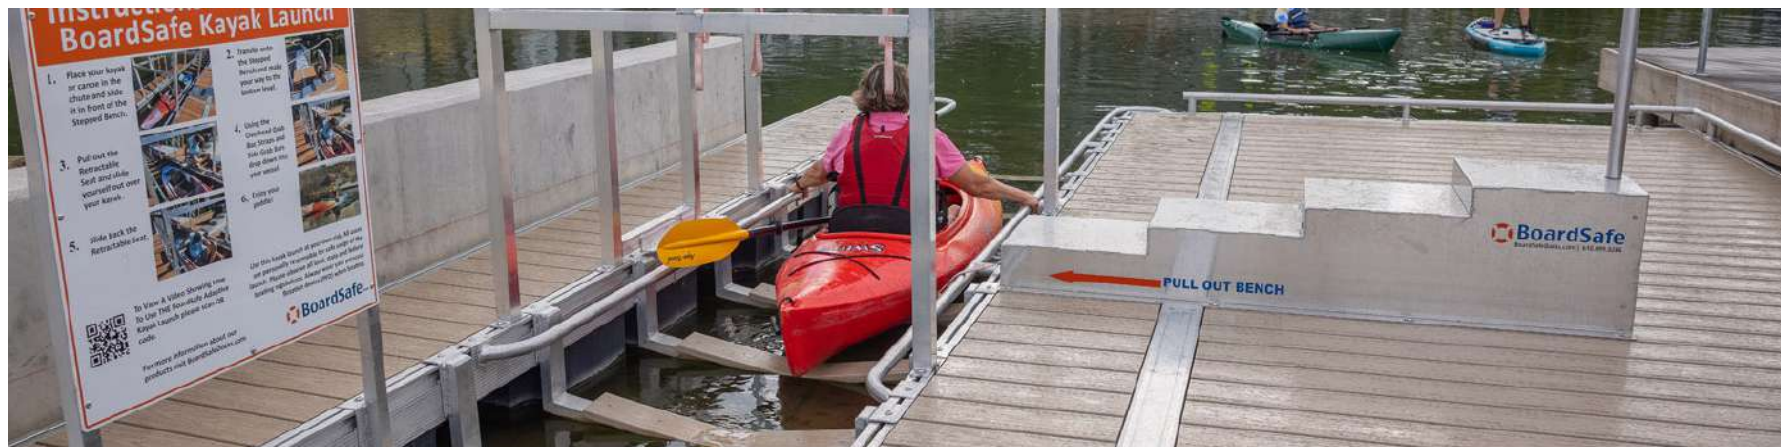
Adaptive hand launch located in Fairport. Adaptive elements include a transition bench, overhead grab bars, clear instructions for use, and guardrails at the edge of the dock.

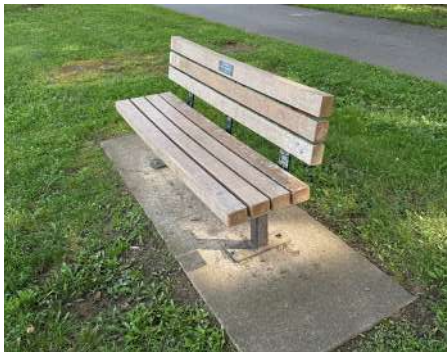
### PARTIAL

Benches were often disconnected from the Erie Canalway Trail and paved walkways near the Erie Canal and NYS Canalway Water Trail, posing a challenge for those using a mobility device. A firm, stable connection to the walkway with adequate clearance on one side of the bench would enhance accessibility. (Baldwinsville)

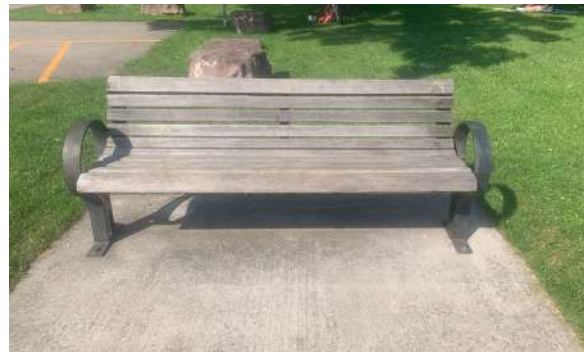
### PARTIAL

This bench is affixed to a larger concrete pad that connects to the Erie Canalway Trail. Connections like this not only provide a firm, stable surface for those with mobility impairments, but they also create a tactile cue for those with visual impairment. Accessibility for this bench would be further enhanced with a firm, stable area on one side of the bench.

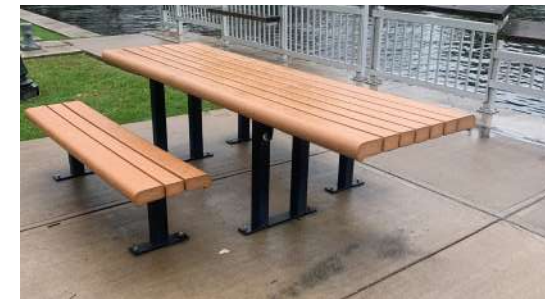
**MEETS STANDARDS**

This table is installed on a firm, stable surface and has an extension so those in a wheelchair would have adequate clearance. (Cleveland)

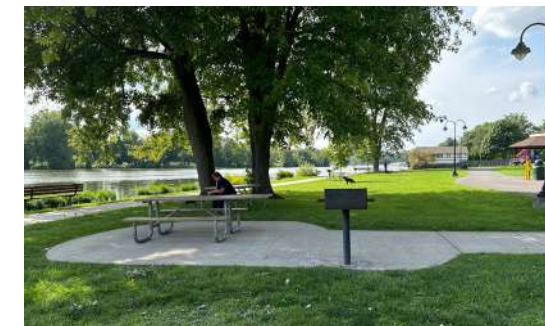
**PARTIAL**

This picnic area is in close proximity to an adaptive launch and connected by a firm, stable surface, however the table does not have an extension for someone using a wheelchair. (Baldwinsville)

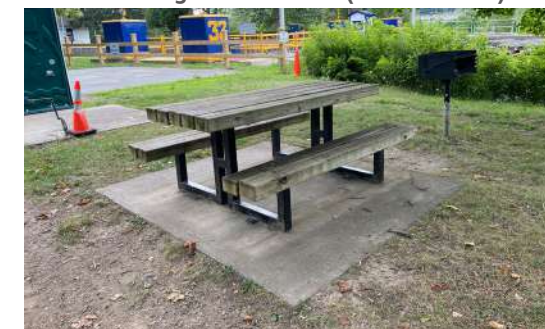
**DOES NOT MEET STANDARDS**

A wheelchair may have adequate clearance to roll up to the end of this table but it is not connected to the paved trail or grill by a firm, stable surface, creating a barrier for those using a mobility device. (Rochester)

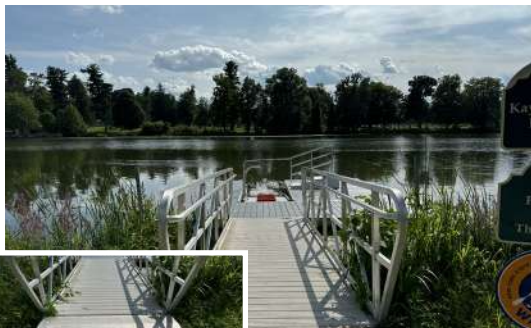
### MEETS STANDARDS

This adaptive launch has a plate connecting the paved walkway to the gangway to enhance access for those using a mobility device. (Baldwinsville)

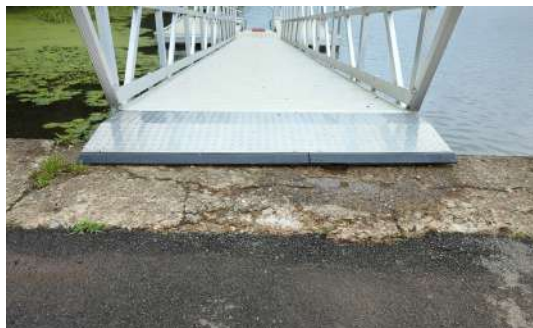
### PARTIAL

This adaptive launch connects to an uneven concrete/asphalt surface and has a steep incline, which may pose issues for those using a mobility device. (Halfmoon)

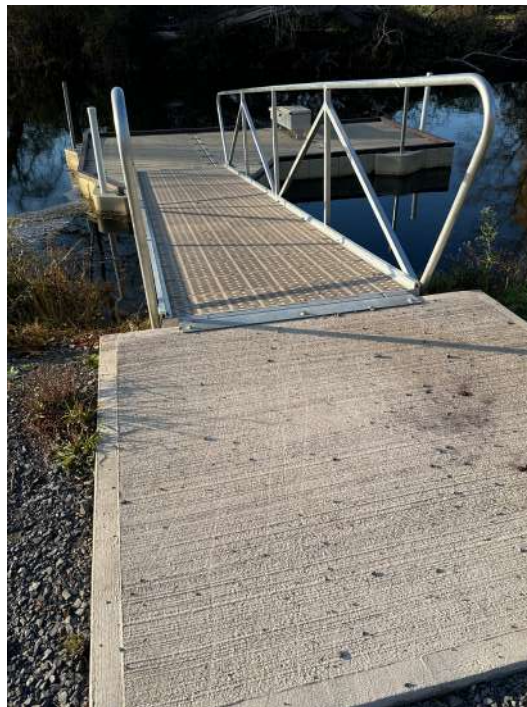
### PARTIAL

This adaptive launch has a noticeable lip from the rocky path to the concrete landing, both of which would pose a challenge for access. (Palmyra)

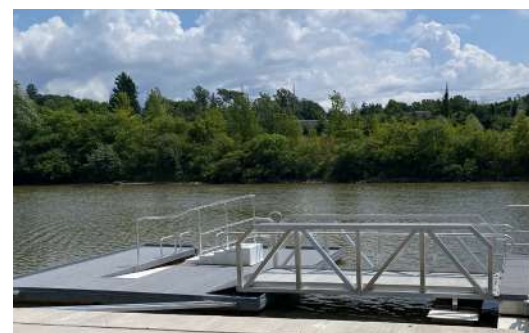
### MEETS STANDARDS

At this launch, someone can stand on the opposite side of the rollers to assist a person with a disability. (Pittsford)

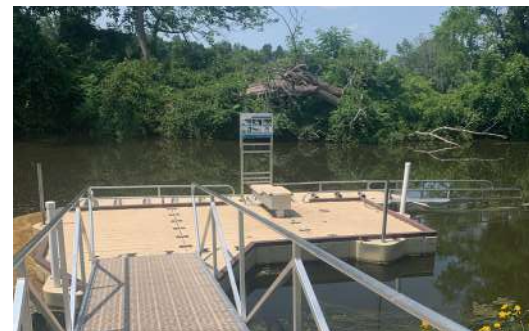
### PARTIAL

There is no landing on the far side of the rollers for someone to place themselves and assist a person with a disability to launch. (Palmyra)

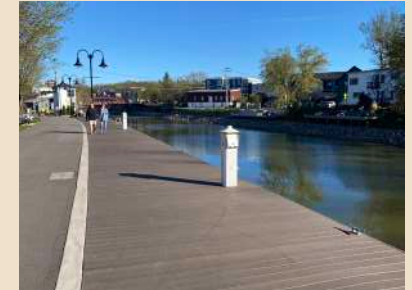
*The docks are flush with the paved trail, which provides access to shops and services in the Village.*

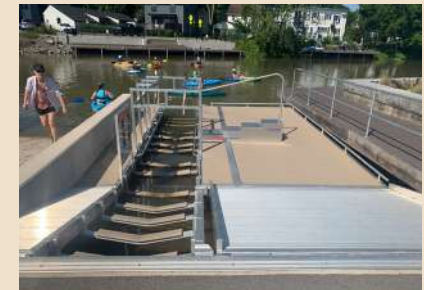
*Fairport's adaptive launch is located adjacent to a paddlecraft rental company that offers adaptive equipment rentals.*

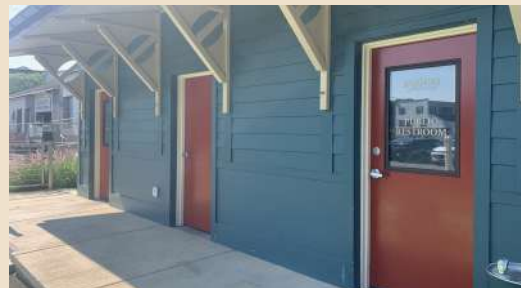
*ADA-compliant, single-occupancy public restrooms are available next to the canal.*

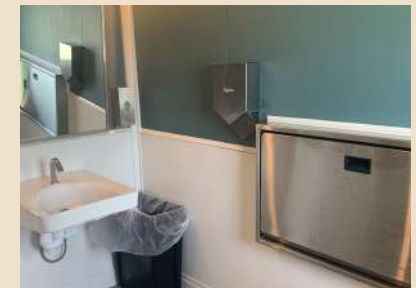
*Adult changing tables were identified as a key need in design of the restrooms.*
